Manhole Inspection Summary

Manhole # **S15GG1018MH**

Insp Date: **8/5/08 1:24 PM**

Location Address: **2601 OSWEGO AVE**

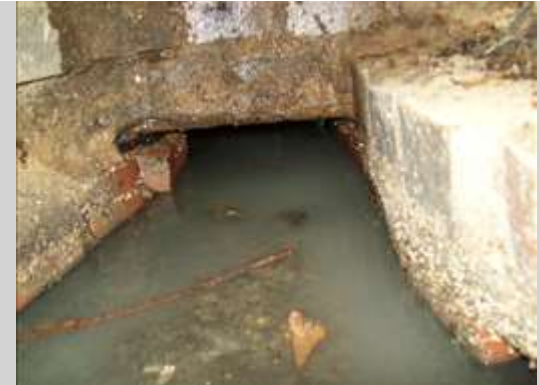
12 O'Clock Outflow

8 in. Circular Gravity Sewer
Pipe Out @ 12 O'Clock

Pipe Height: (in.) Direct
Pipe Material: **Clay** ☐ Pipe Lined
Invert Depth: **3.30** (ft.) Flow Characteristics: **Slow**
Deposits: ☐ None ☐ Mud ☒ Sludge ☒ Debris ☒ Grease
Silt Depth: **2** (in.) Deposits Extent: **Light**
Infiltration: **None** Pipe Seal Cond: **Sound**

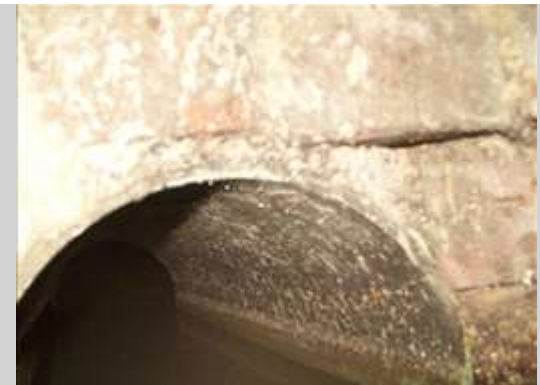
3 O'Clock Inflow

8 in. Circular Gravity Sewer
Pipe In @ 3 O'Clock

Pipe Height: (in.) Direct
Pipe Material: **Clay** ☐ Pipe Lined
Invert Depth: **3.24** (ft.) Flow Characteristics: **Slow**
Deposits: ☐ None ☐ Mud ☒ Sludge ☐ Debris ☐ Grease
Silt Depth: **2** (in.) Deposits Extent: **Light**
Infiltration: **None** Pipe Seal Cond: **Sound**

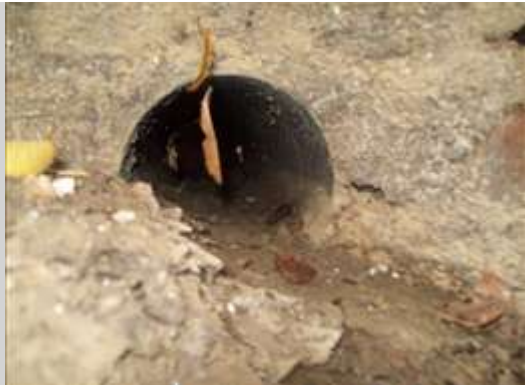
7 O'Clock Inflow

6 in. Circular Gravity Sewer

Pipe In @ 7 O'Clock

Deposits: ☒ None ☐ Mud ☐ Sludge ☐ Debris ☐ Grease

Infiltration: **None**

Pipe Seal Cond: **Sound**
